Failure Analysis on U-Bend Header Tube of Boiler Economizer

Nur Farhana Hayazi^{1,*}, Shaiful Rizam Shamsudin^{1,2} and Rajaselan Wardan^{1,2}

¹School of Materials Engineering, Universiti Malaysia Perlis, Kompleks Pengajian Jejawi 2, Jejawi 02600 Arau Perlis.

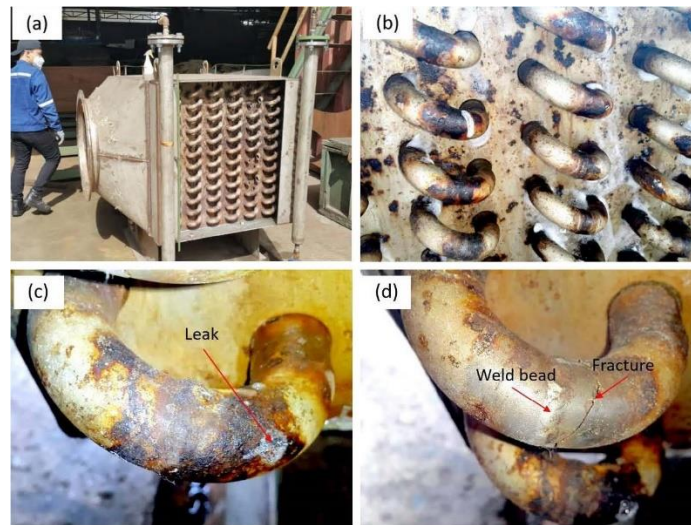
The u-bend header tube of boiler economizer found to be failed after 5-6 years in service (Figure 1(a)-(d)). A sudden pressure drop was recorded by the person in charge. From the observation, the boiler header was found leaked on the u-bend tube area. The materials of header tubes made of SUS 304 grade stainless steel. The objective of this analysis is to investigate the failure evidence presented by the u-bend tube and to examine the primary cause of the failure through the metallurgical analysis method.

Figure 1: Camera photographs on boiler economizer; (a) header tube, (b) close-up views on defected u-bend tubes, (c) leaked area as indicated by the small white bubbles and (d) transverse crack adjacent to the weld bead.

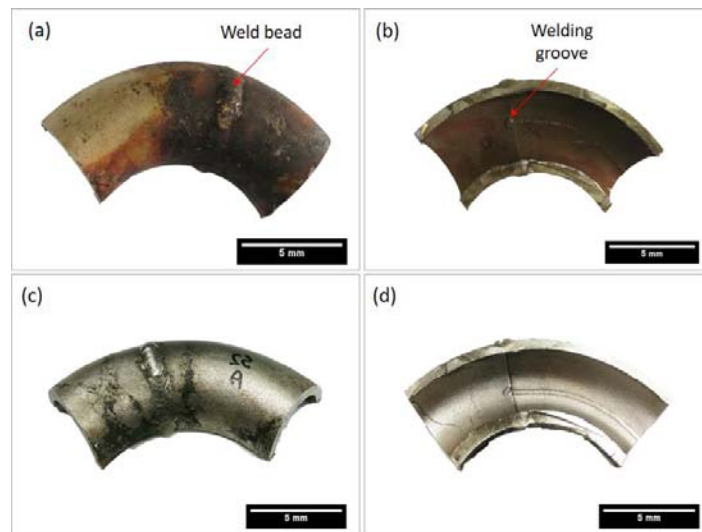
Figure 2 (a) - (d) show a camera photographs of as-received u-bend header tubes both on shell and tube sides. The surface of the header tube is found to be covered with brownish rust on both shell and tube side. The shell side surface looks more severe to corrode as compared to the tube side. In as-cleaned samples, there is a residual blackish oxide stain and slightly brownish rust (Figure 2(c)). While the tube side surface is seen to be shiny and rust-free (Figure 2(d)). These observations indicate that the rust is worse on the shell side rather than the tube side where the fluid flowing through in it.

Figure 2: Camera photographs on (a) shell side, (b) tube side of as-received, and (c) shell side and (d) tube side images of as-cleaned of u-bend header tube.

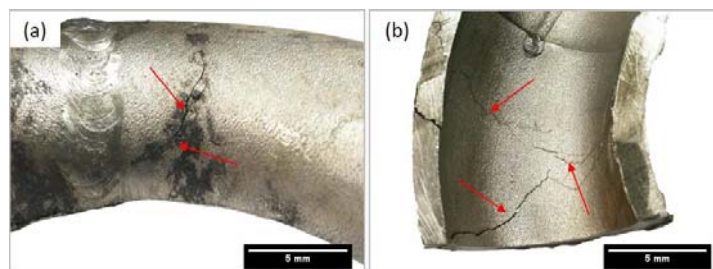
The closed-up camera photographs further reveal the appearance of cracking on the u-bend header tube (Figure 3). At the shell side, there is a crack transversely propagates encircling the tube that occurs adjacent to the weld bead (Figure 3(a)). There are some blackish stains on the crack morphology which indicates that there is a corrosion reaction surrounding the crack area. Figure 3 (b) shows the cracks are found everywhere along the u-bent tube on the tube side. However, there were no signs of cracking on the weld bead. This proves that welding procedures are performed well without any defects. Additionally, no corrosion marks visually detected on the tube side.

Figure 3: Closed-up camera photograph images on as-cleaned of typical (a) shell side and (b) tube side. Red arrows indicate the cracking morphology.

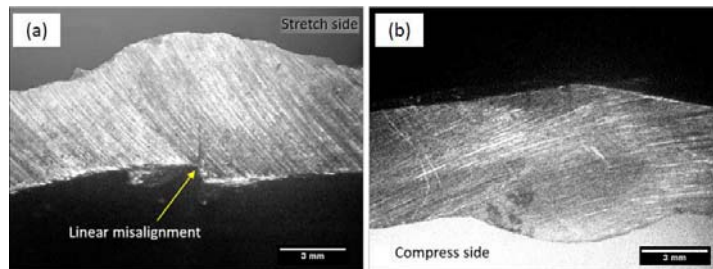
Observations by stereomicroscope around the weld bead both on shell and tube side found no signs of cracking and corrosion occurred (Figure 4(a) and (b)). Some welding imperfection such as linear misalignment and incomplete penetration (lack of root fusion) spotted on weld joint. Generally, this imperfection act as an initiation site of the stress corrosion cracking (SCC) [3]. However, there is no SCC marks detected here. This further strengthens the fact that the welding works to join two semi-bent tubes do not have any problems at all, instead, it was carried out perfectly.

Figure 4: Stereomicroscope images at cross-sectional (parallel to stress direction) of the as-cut weld bead area on (a) stretched and (b) compressed side.

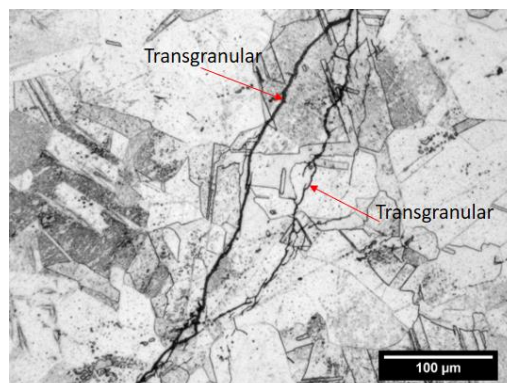
Etched metallographs images on the header tube metal are shown in Figure 5. There are single cracks together with hairline cracks morphology which dominated by transgranular cracking on the cross-sectional tube wall. This crack finally results in the enlargement of crack opening to be more severe. Both hairline and transgranular cracks indicate that the tube metal is under stress due to bending works that occur in a plastic manner beyond the materials yield point. In contrast, there is not a clear intergranular cracking that can be clearly detected. Therefore, the corrosion factor is not the main cause of the failure. Additionally, the absence of a slip band grains is believed due to the optimum heat treatment process performed on the u-bend tube works well and aidful [1-2].

Figure 5: Etched metallographs image on the header tube is dominated by transgranular cracking.

The leakage failure of the u-bend tube is due to a crack caused by stress due the bending procedure that may be performed by the hot or cold work methods. The lack of branching cracks and the absence of slip band grains indicate that the bending and heat treatment (or stress relief treatment) procedure works well, as the inadequacy signs of residual stress in the microstructural analysis observation. However, the cracks are believed to occur earlier that is during the bending procedure. The appearance of brownish rust on the tube surface due to the presence of small content of sulphur elements in the boiler environment. It does not penetrate inward and only affects the surface layer of the metal. However, at the opening cracks, this sulphur penetrates the metal tube through the crack narrow space which eventually speeds up the leakage of the tube. Corrosion is not the main root cause of header tube failure. As well as the welding imperfections. In conclusion, the material (SUS304 grade stainless steel) is found to be the appropriate materials selection for the header tube.

OES Results of the as-received u-bend header tube boiler is shown as in Table 1. This results proved that SUS304 grade stainless steel is the best material selection used for the tube boiler since it is not affecting the tube boiler failure. The material selection factor has been ruled out. The plant technical should perform a periodic NDT inspection for early detection and damage assessment to boiler tubes. Secondly, the application of u-bent header tubes by mechanical bending methods is indeed prone to crack failure, thus it is proposed to replace them with u-bend tubes fabricated by the casting method.

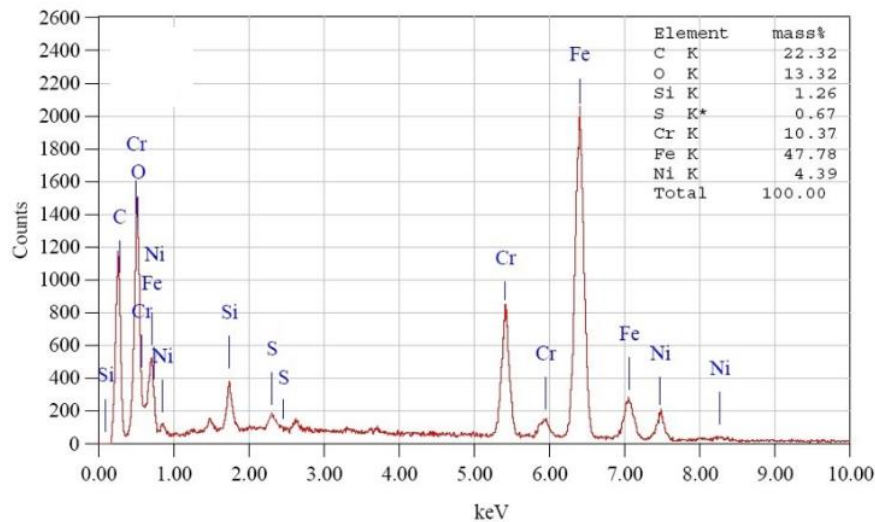
Figure 6 shows the elemental EDS pattern on the shell side surface. The appearance of brownish corroded surface on the shell side was attributed to the oxidation and the presence of slightly sulphur elements which is believed as a result of sulphur content in the condensation of flue gas.

Figure 6: Elemental EDS pattern on u bend header tube at shell-side surface.
