Unmanned Aerial Vehicle Technology Use in Visual Road Inspection at Ft005, Johor Bahru-Melaka

Keywords: Visual road inspection, UAV technology, photogrammetry method, Pavement Condition Index (PCI)

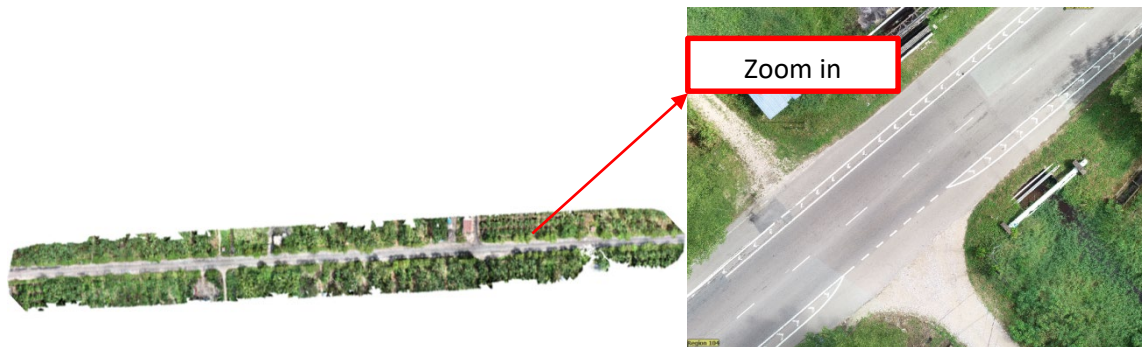
Figure 3. Orthomosaic images produced using Pix4DMapper.

These three processes produced the orthomosaic image shown in Figure 3. The zoom-in image is the UAV image that can be seen using the orthomosaic image.

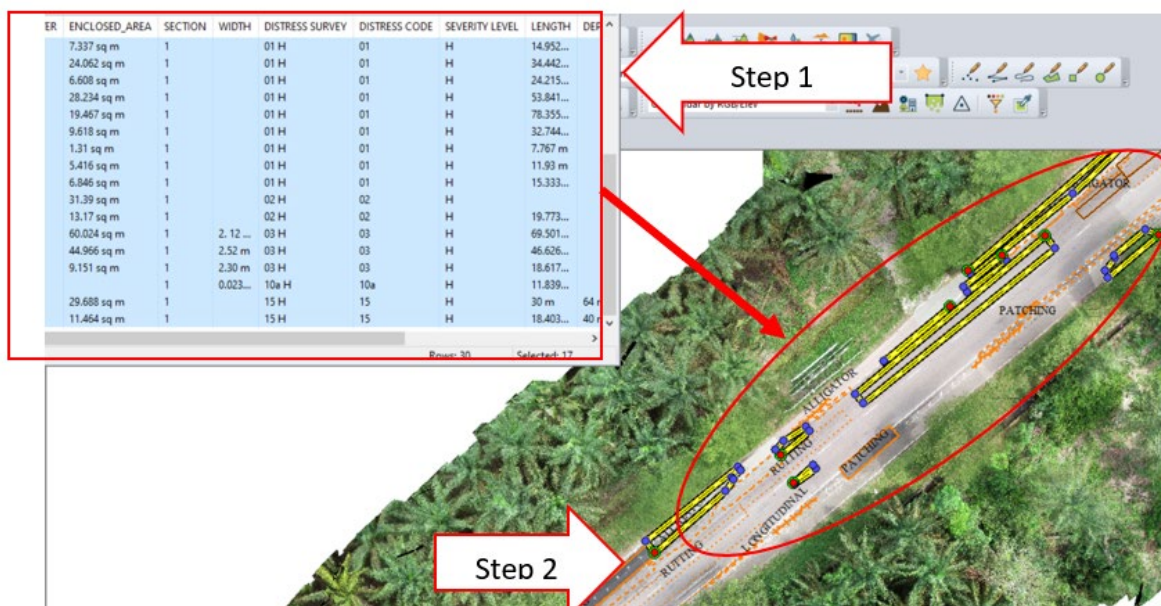
Figure 5. Steps to determine the location of pavement distresses.

Figure 5 shows the example of a query to determine the location of the high severity level pavement distress in section 1. The severity level of pavement distress is divided into three categories: low (L), medium (M), and high (H). Section 1 will provide an example of a high severity level for this query. An example of a query is as follows:

The data obtained from Figure 5 represents the location of all types of pavement distresses that are at a high level of severity in Section 1.
