**AN INVESTIGATION OF FATIGUE CRACK GROWTH
BEHAVIOR OF UIC 54 PROFILE IN HIGH SPEED
RAILWAY APPLICATIONS**

A thesis submitted in fulfillment of the requirements for the degree of
Master of Science in Mechanical Engineering

**School of Mechatronic Engineering
UNIVERSITI MALAYSIA PERLIS
2017**

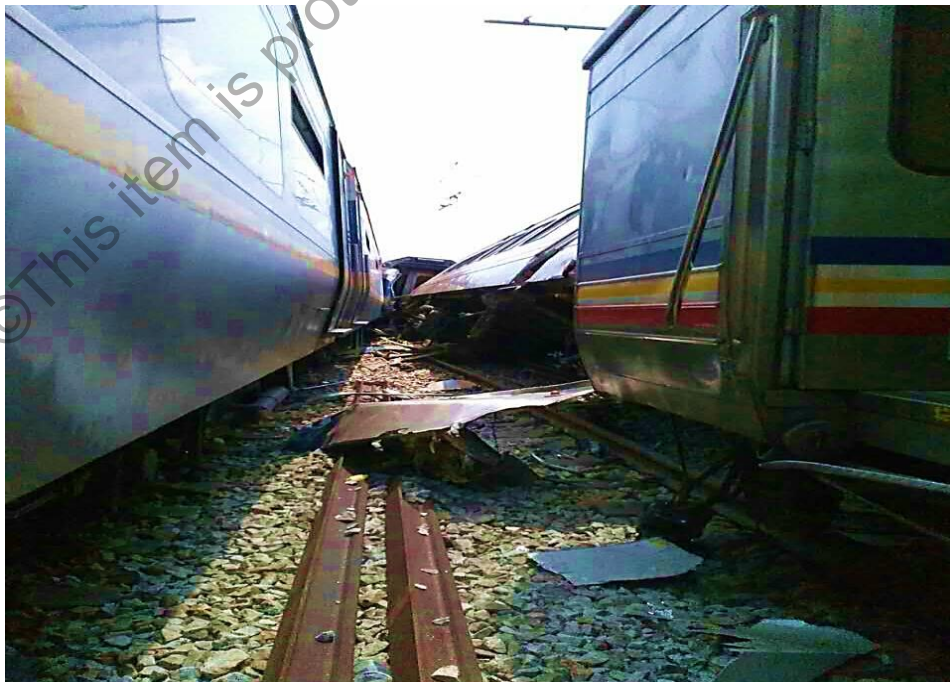
Figure 2.1: Derailments of Train in Malaysia (KTM BERHAD, 2017)

According to Ringsberg et al. (2001), the life of a fatigue crack is divided into 3 phases. Phase I is about the shear stress applied to the surface which was initiated the crack, phase II is the transient crack growth behavior and phase III is the subsequent tensile and shear driven crack growth. The engineering structure deterioration due to fatigue has been a major issue faced by engineers. Akeel et al. (2011) reported that the estimated fatigue failure is more than 70% in engineering structure and this leads researchers to investigate on crack propagation, crack path and stress intensity factor as shown in Figure 2.1.

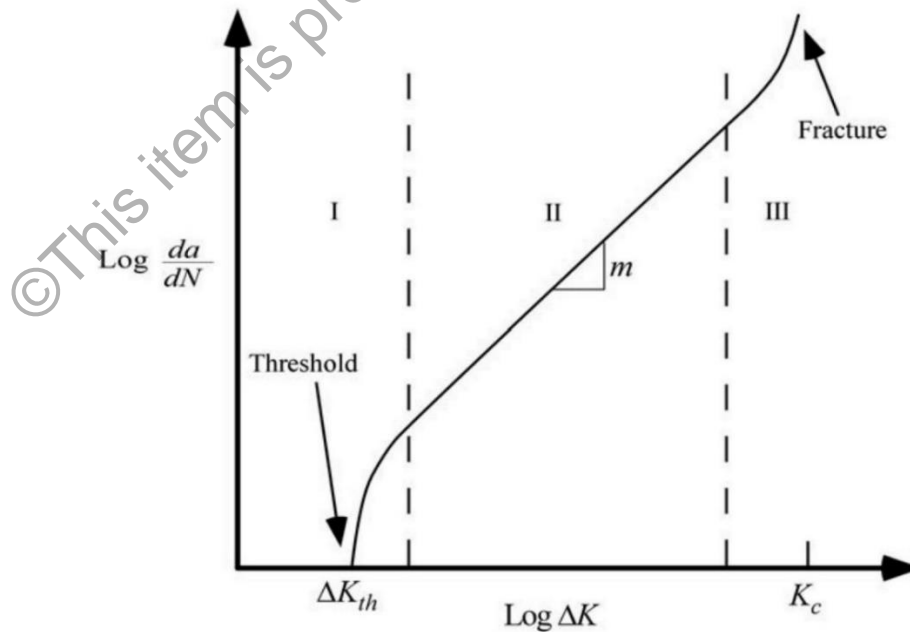
Figure 2.2: Logarithm of the fatigue crack growth rate da/dN versus the logarithm of the stress intensity factor range, ΔK .

The fatigue crack growth studies are conducted by many researchers with dynamic loading. There are various studies on fatigue behavior based on rail profile types as stated by Grassie et al. (1993). However, there is a number of controversial problems and unanswered question in those studies. Paris et al. (1963), presented that the fracture mechanics are one of the tools to study the fatigue crack growth in metals. In general, FCGR curve is conducted in semi or wholly empirical manner. The researchers widely used the Paris law which is published in Paris et al. (1961). Figure 2.2 is a schematic log-log plot da/dN versus ΔK , which illustrates typical fatigue crack growth behavior in the metallic material. Anderson (2005), stated that the sigmoidal curve consists of the three distinct regions and a linear region of the log-log plot that can be described by the power law in Equation 2.1
